WEEKLY STATUS REPORT

BCP Project No.:	C224099	EPA Consent Order No.:	CERCLA-02-2017-2021	Date:	09/13/2019
Project Name:	BRT Powerhouse 153 2 nd Street AKA 322 3 rd Avenue, Brooklyn, NY 11215				
Remediation Activities (Week of September 9, 2019): <ul style="list-style-type: none">Continued gauging and product recovery via absorbent sock as necessary.Brookside Environmental and Clean Harbors (Site remediation contractors) mobilized to the Site to continue the boiler house lateral discharge tunnel sludge removal in general accordance with the USEPA Building Materials PCB Cleanup Plan submitted to the USEPA on April 9, 2019. Brookside Environmental and Clean Harbors opened additional access holes at the east tunnel, removed large debris (concrete, brick, wood, etc.) by hand and loaded the debris into drums, pumped oily water from the tunnel into the frac tank onsite, and used a Cusco guzzler truck to vacuum the rest of the material (sludge, soil, smaller debris, etc.) out of the tunnel. Twenty-one (21) drums of hazardous PCB material were generated by the sludge removal work this week.Brookside Environmental constructed the formwork for the concrete tunnel plugs at the three (3) tunn

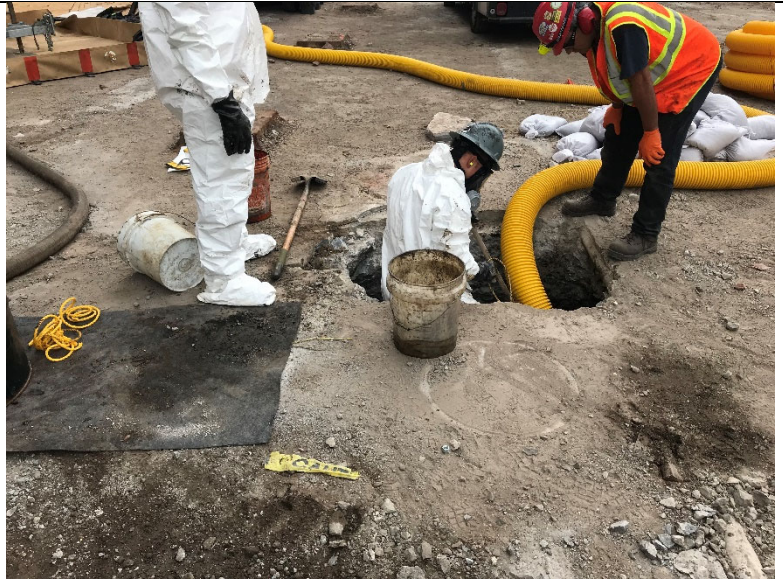
Photo 1 – Looking west at the east boiler house lateral discharge tunnel. Clean Harbors uses the Cusco guzzler to remove sludge and other material from the tunnel.

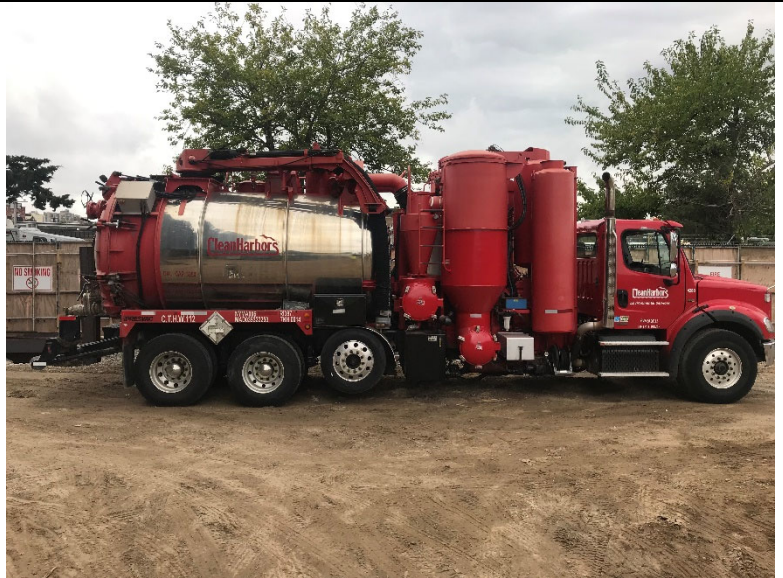
Photo 2 – Facing south in the west yard. View of the Clean Harbors Cusco guzzler truck as it arrives onsite.

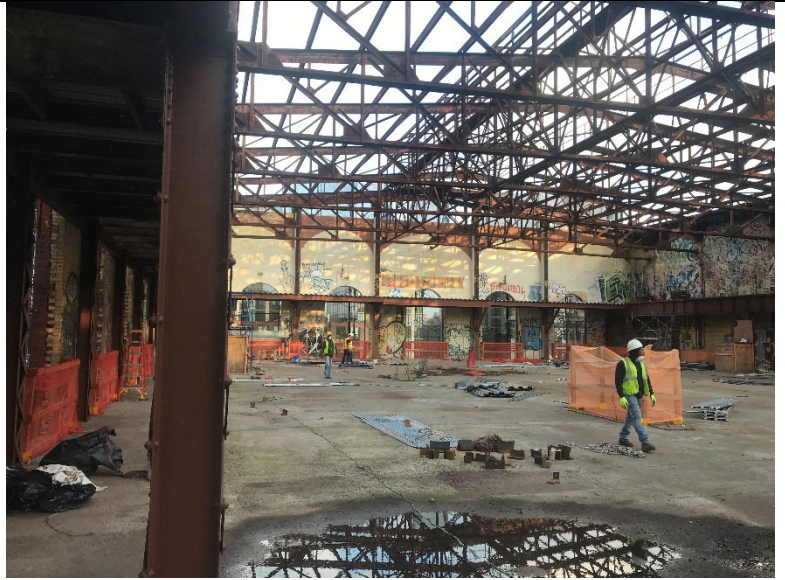
Photo 3 – Looking west at the fourth floor of the turbine hall. Maspeth and US Spray continue steel repair and steel scraping work.

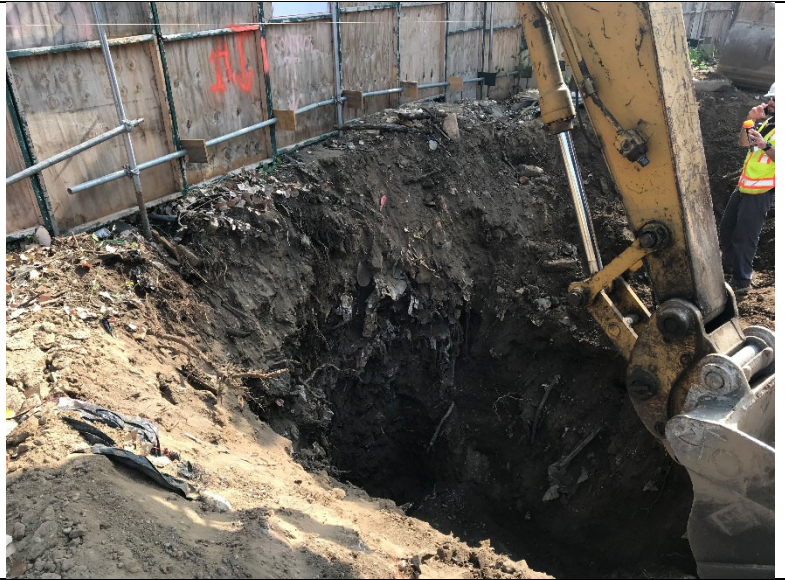
Photo 4 – Looking north at the northwest property line. Structure Tech excavates additional test pits to inspect the SOE obstruction.
